Effects of Safety Chains on Dynamics of Truck and Full Trailer Combinations in Event of Coupling Failure

Adam Ritzinger, Rob Di Cristoforo, Daniel Nolan, Wayne Baker, and Kieran Heinze

Transportation Research Record: Journal of the Transportation Research Board, No. 2547, Transportation Research Board, Washington, D.C., 2016, pp. 19-24. DOI: 10.3141/2547-03

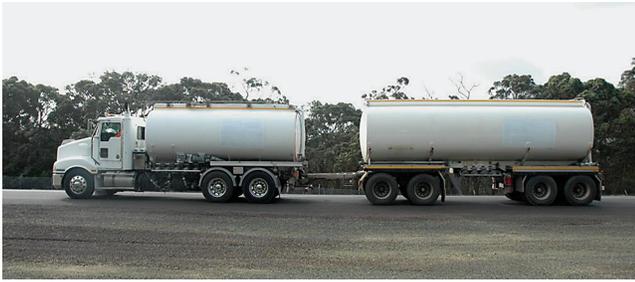
FIGURE 1 Test vehicle.

The transport company provided a representative truck and full trailer for use in the field tests. It comprised a three-axle straight truck and a four-axle full trailer, both fitted with tanker bodies (Figure 1). The truck was fitted with a new pin-type coupling that featured a unique remote release mechanism, installed by the transport company’s maintenance contractor. The mechanism allowed the pin coupling to be disengaged by activating a switch located within the truck cabin; this disengagement could be done while in motion. The coupling was also fitted with two 780-mm (31-in.) safety chains, manufactured and installed by a reputable local supplier (Figure 2). The chains were crossed underneath the coupling, as recommended by the supplier, to support the drawbar and limit lateral movement.

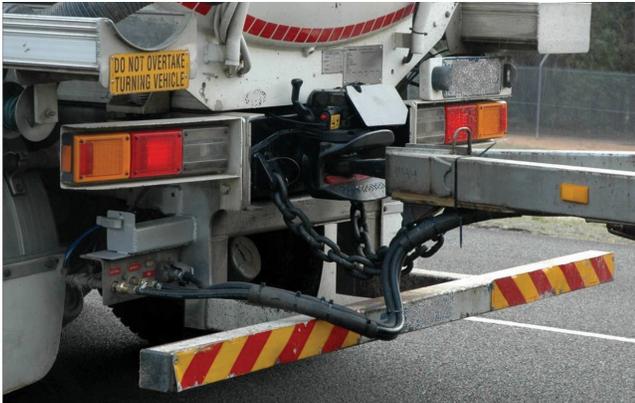
FIGURE 2 Pin coupling, release mechanism, and safety chain arrangement.
